## 2 Common air leakage paths

## 2.1 Descriptions of air leakage paths

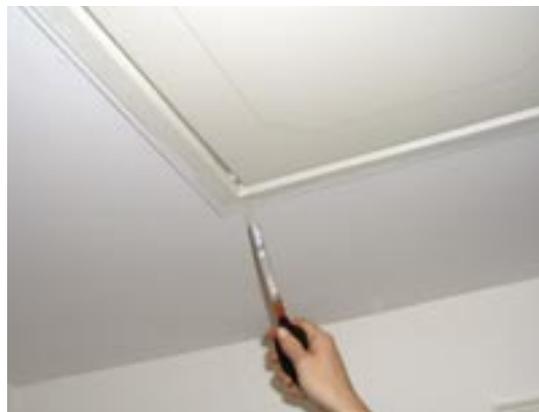
Figure 2 Air leakage through gaps around a loft hatch.

- 8 Loft hatches:
  - Loft hatches that do not fit properly (prefabricated loft hatches can become twisted as they are installed) (Fig. 2).
  - Inadequate seals between the hatch and the frame.

(Note: condensation can be an issue if the loft hatch does not fit – warm moist air from the dwelling rises into the loft and condenses on cold surfaces, such as roof timbers and roof underlay.)

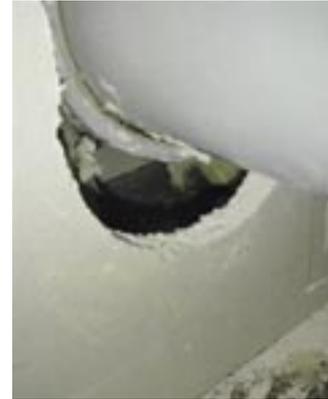
Figure 3 Gap around soil pipe at back of toilet.

12 Gaps around service pipes (these gaps can often provide the largest air leakage paths in dwellings) (Fig. 3):

- Gaps left around service pipes, cables and ducts that pass through the dwelling's external fabric can be a major contributor to poor airtightness.
- Large holes often created for much smaller diameter pipes to pass through.
- Gaps and holes around service penetrations often hidden from view behind baths, vanity units and kitchen units.
- Cuts and holes in vapour control membranes (used as air barrier for framed construction) made to accommodate pipes, cables and ducts as they penetrate through the dwelling's external walls resulting in large air leakage rates.

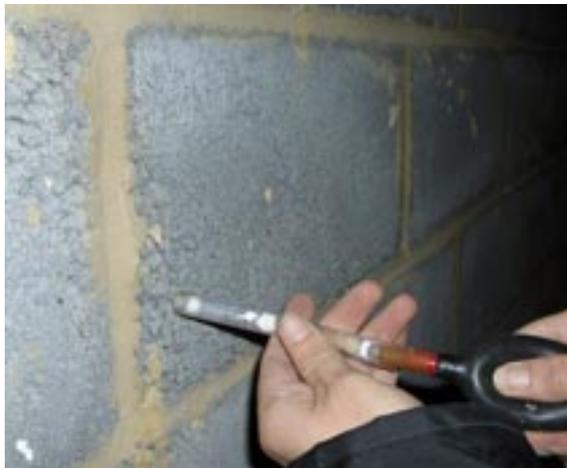
Figure 4 Air permeability through gaps in a blockwork wall.

13 General air leakage through walls (Fig. 4):
